Analysis of Measurement Devices for Detecting Heat Loss in Existing Residential Buildings

Abstract: This article analyzes modern measurement instruments used to identify heat losses in existing residential buildings. It is shown that heat losses in buildings primarily occur through external structures, such as walls, roofs, windows, doors, and balcony slabs. The study compares the technical specifications, advantages, and limitations of three types of infrared thermographic cameras: Bosch GTC400, UNI-T UTi120S, and UNI-T UTi320E. These devices were tested in practical experiments, particularly in a four-story reinforced concrete panel building, and their effectiveness was evaluated. The results indicate that the UTi320E, with its high accuracy, is the most effective for precise detection of heat losses. While the Bosch GTC400 provided sufficient results for medium-sized objects, the UTi120S proved suitable mainly for small objects and rapid inspections. Based on the research findings, criteria for device selection were developed, and practical recommendations for reducing heat losses were provided. This article is of practical significance for construction specialists, energy orga

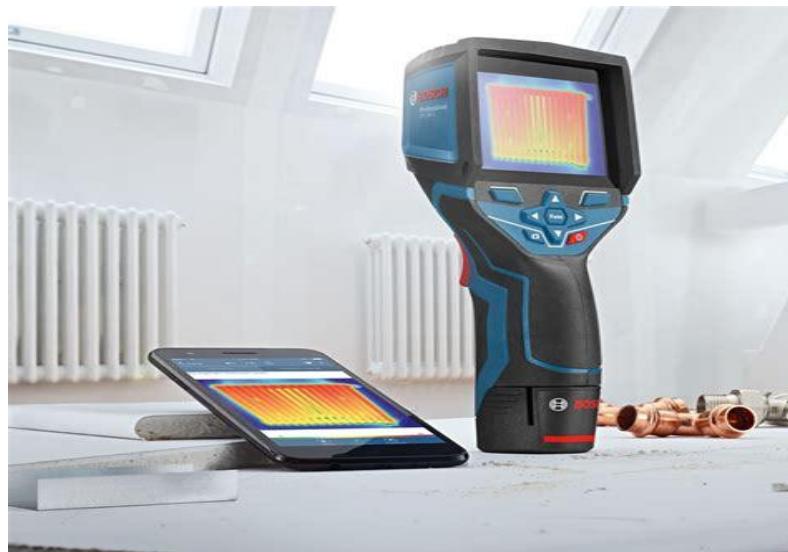
The Bosch GTC400 is a mid-range thermographic camera equipped with a 160×120 pixel detector. Practical tests showed that this device was sufficient for detecting general heat loss zones. Zones with temperatures $3\text{--}4^{\circ}\text{C}$ lower at joints were clearly recorded, but their boundaries appeared blurred, making it difficult to precisely delineate thermal bridges.

Although the device's sensitivity ($\text{NETD} \leq 0.1^{\circ}\text{C}$) was sufficient to detect minor temperature differences, small temperature gradients in high-accuracy areas occasionally merged with background noise. The camera's interface was very user-friendly, with a $3.5"$ touchscreen and an intuitive menu system, which expedited the testing process. Its weight (0.55 kg) was relatively light, allowing for extended fieldwork.

Fig.1 Thermographic camera Bosch GTC400.

However, the main limitation of the GTC400 is its measurement accuracy of $\pm 3^{\circ}\text{C}$. Under the test conditions (outdoor temperature -8°C , indoor $+18^{\circ}\text{C}$), this error prevented some minor thermal bridges from being captured. Nevertheless, the device can be recommended as a convenient option for initial diagnostic energy audits.

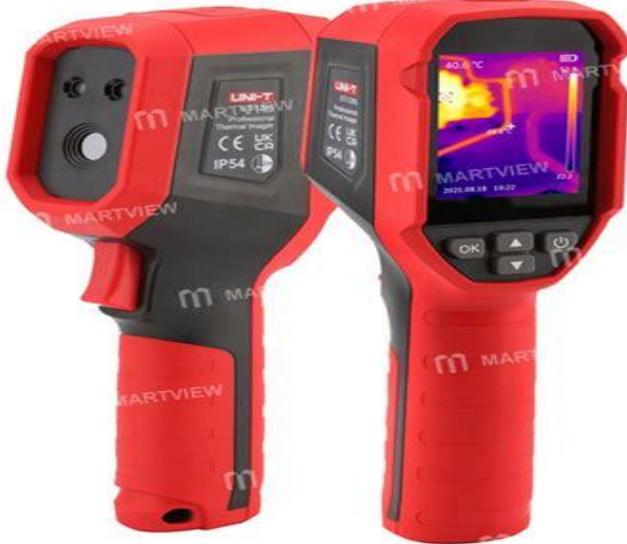
The UNI-T UTi120S is the most affordable and compact model, with a 120×90 pixel resolution. During the tests, this device was only capable of showing major heat loss zones. For example, temperature differences of $4\text{--}6^{\circ}\text{C}$ around window perimeters or exposed balcony slabs were clearly visible, but $1\text{--}2^{\circ}\text{C}$ differences at wall joints were not detected at all.

Fig.2 Thermographic camera UNI-T UTi120S.

The camera's low-resolution detector significantly reduced the accuracy of the thermograms. As a result, wall cracks, micro thermal bridges, and areas with condensation risk were not identified. The NETD sensitivity was also low (≤ 0.1 °C), insufficient for high-precision measurements.

However, the UTi120S has advantages: very low weight (0.35 kg) and ease of use. The device is equipped with a simple interface, a 2.4" screen, and can be connected to a computer via USB. It is designed not for large objects but for rapid inspection of small objects or individual elements.

Under test conditions, this device's technical limitations made it unsuitable for creating a complete heat loss map of a large object like a four-story building. Therefore, it is only recommended for preliminary inspections or small rooms.

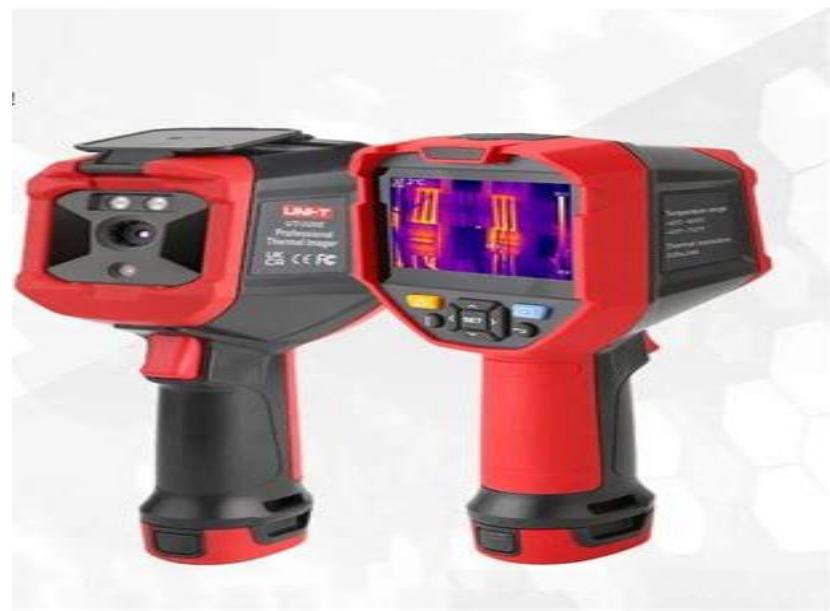
The UNI-T UTi320E is the highest-class device in terms of technical capabilities. It is equipped with a 320×240 pixel detector and a NETD sensitivity of ≤ 0.05 °C. During the tests, it produced the clearest and most precise thermograms. Even zones with temperature differences as small as 0.1 °C were accurately displayed.

Fig.3 Thermographic camera UNI-T UTi320E.

For example, in wall panel joints, thermal bridge areas, and around window perimeters, temperature gradients were clearly visible. Heat leakage on the internal surfaces of the roof

structure was also clearly recorded. The device's high accuracy and sensitivity were decisive factors in practical test analysis.

The UTi320E features a modern interface, a 3.5" screen, and a multifunctional menu system. Although the device weighs 0.62 kg, its ergonomic handle allowed for extended use. Data can be easily transferred via SD card or USB, facilitating rapid analysis of large thermogram datasets.

The analysis showed that the UTi320E provides the most effective results for mapping heat losses in large objects, particularly four-story buildings. Its high accuracy, sensitivity, and stable performance make it the optimal choice for professional energy audits and construction diagnostics.
